Experimental analyses of metal-composite bonded joints: damage identification

Ricardo de Medeiros, Emanuel Nunes Borges and Volnei Tita*

Abstract

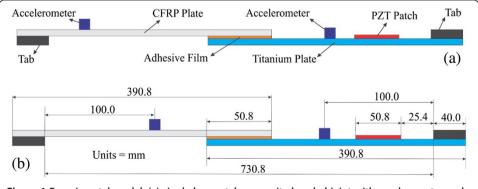
Figure 1 Experimental model: (a) single lap metal-composite bonded joint with accelerometer and piezoelectric transducer attached to the titanium part and (b) important dimensions.

Piezoelectric ceramic is capable of providing a very precise signal of voltage due to very small amounts of strain, which is required for sensor application. The same effect is true in reverse, i.e. a signal of strain is provided by the transducer due to the voltage applied. Hence, a controlled input signal can produce an efficient response in the material, when the device is used as an actuator. In this work, the PZT transducer was used only as a sensor, not as an actuator. The piezoelectric transducer was bonded in the titanium surface by using a vacuum bag for compacting and removing volatile during the cure process of the adhesive, which was performed at room temperature. Figure 1 shows the entities used during the experimental tests and important specifications of dimensions.

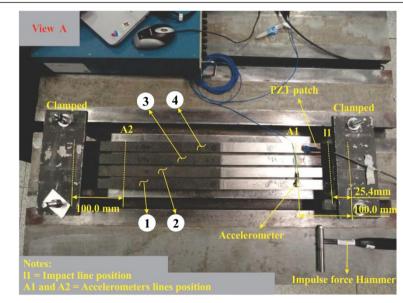
Figure 4 Assembly and position of the specimens.

Some important aspects need to be considered due to the specimen assembly. For this reason, all the specimens were assembled together in order to minimize undesired effects caused by the clamped devices, for example, pre-stress due to assembly (Figure 4). However, these effects were not evaluated during the experimental analyses, because the specimens were fixed together and the axial load created by the clamped device was kept as low as possible in order to avoid changes in the dynamic behavior of the specimens (*c.f.*, Figure 4). However, it was not considered the vibration effects from one specimen to others and vice-versa.

Based on the experimental set-up shown by the Figure 4, it was investigated the vibration-based damage identification for metal-composite bonded joints. It is important to notice that the fundamental idea for this method consists on the principle that the damage changes the physical properties (damping and stiffness) of the structures. Hence, these changes cause modifications in modal properties (natural frequencies, modal damping and mode shapes). For instance, it is possible to observe reductions in stiffness due to cracks. Therefore, damage can be identified by analyzing the changes in vibration behavior of the structure. Hence, the knowledge of the vibrational behavior of a structure can be used to determine the existence as well as the location and extension of damage.
