Experimental fatigue and aging evaluation of the composite patch repair of a metallic ship hull

This article describes the fatigue analysis of a composite repair that was applied to the metallic hull of a Floating, Storage and Offloading (FSO) platform. The main objective is to address the durability and thus the expected operational life of the repair, with emphasis on the adhesive bonded interface between metal and composite. The adoption of this repair technology is increasing in Brazil and abroad and little is known about its long term performance when applied to harsh, dynamic applications like naval structures in operation. During repair installation, more than a year ago, an array of Bragg grating extensometers was applied for reliable structural behavior monitoring. Dynamic strain samples were acquired daily and remotely sent to shore for processing. In parallel, lap shear fatigue tests were performed at the lab in order to establish a suitable defect growth fatigue curve, concerning repair disbondment. The experimental strain data, together with a specific fatigue curved experimentally defined provided the input of a Finite Element Model of the repaired structure and resu

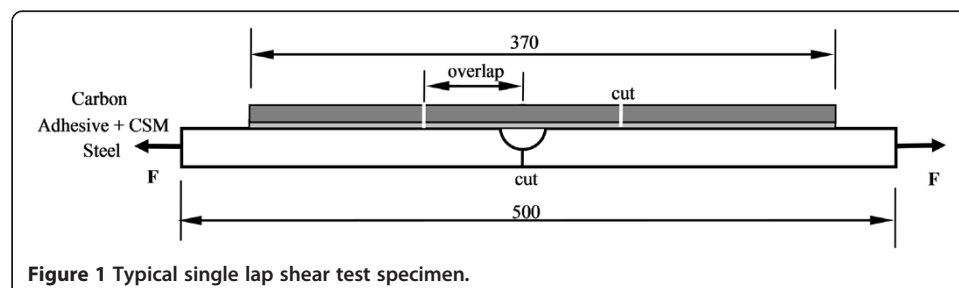
A metallic plate, 8 mm thick, measuring 500x650 mm was laminated at one side using the same scheme proposed for the repair, i.e., a first layer of resin, one layer of glass chopped strand mat (CSM), followed by the 45°/-45° carbon lamination. Figure 1 shows a lap shear specimen. The laminated region had dimensions of 370x650 mm.

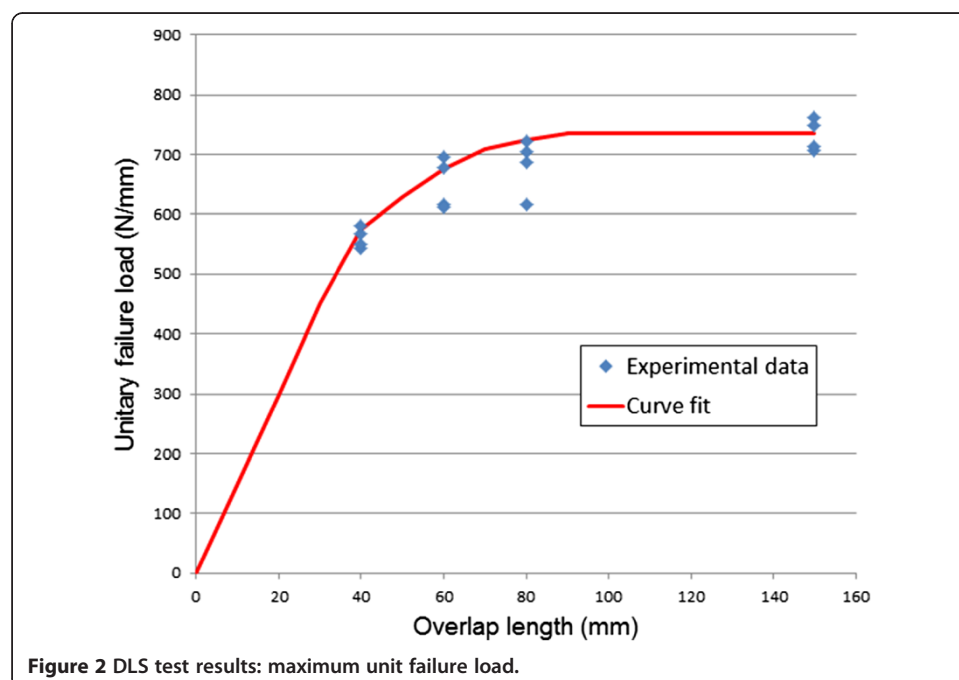
The test results are displayed in terms of unitary failure load against overlap length, as shown in Figure 2. From the graph and according to DNV RP it is possible to define two parameters of the adhesive interface system tested, the first one being a maximum effective overlap length of around 100 mm, beyond which the unit failure load reaches a plateau value of 736 N/mm. The latter figure divided by the former defines the critical shear stress of the system, which results to be 7.4 MPa.

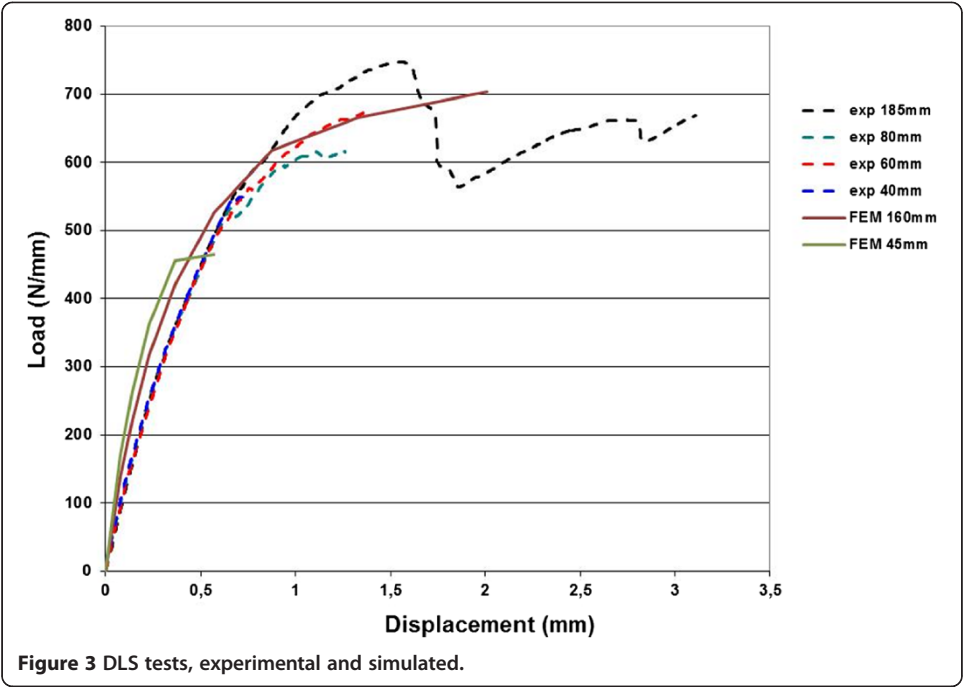
As the DLS specimens had a $-45^\circ/+45^\circ$ carbon fiber arrangement along the axis, E_{lam} was of about 12GPa. Formula (3) indicated a maximum G of 3600 J/m², which proved too high in practice. Experimental results were better fit for a G value of 1600 J/m². Figure 3 shows the results of FEM models of DLS tests with long (160 mm) and short (45 mm) overlap lengths, in terms of unit load versus displacement. Also shown are the experimental results for other overlap lengths.

The model behavior resulted somewhat stiffer, but the non-linear nature of interface behavior was adequately modelled. A failure load of about 700 N/mm for long overlaps was indicated, which is close to the experimental average. The reduction in ultimate load for short overlaps was also captured by the model.

As can be seen, strain energy varies with the square of unit load f - in agreement with formula (3) - up to f around 400 N/mm, which is little more than half the quasi-static failure load. This range is also within the approximately linear behavior of the interface, indicated by the load x displacement curve, as shown in Figure 3. Moreover, within this

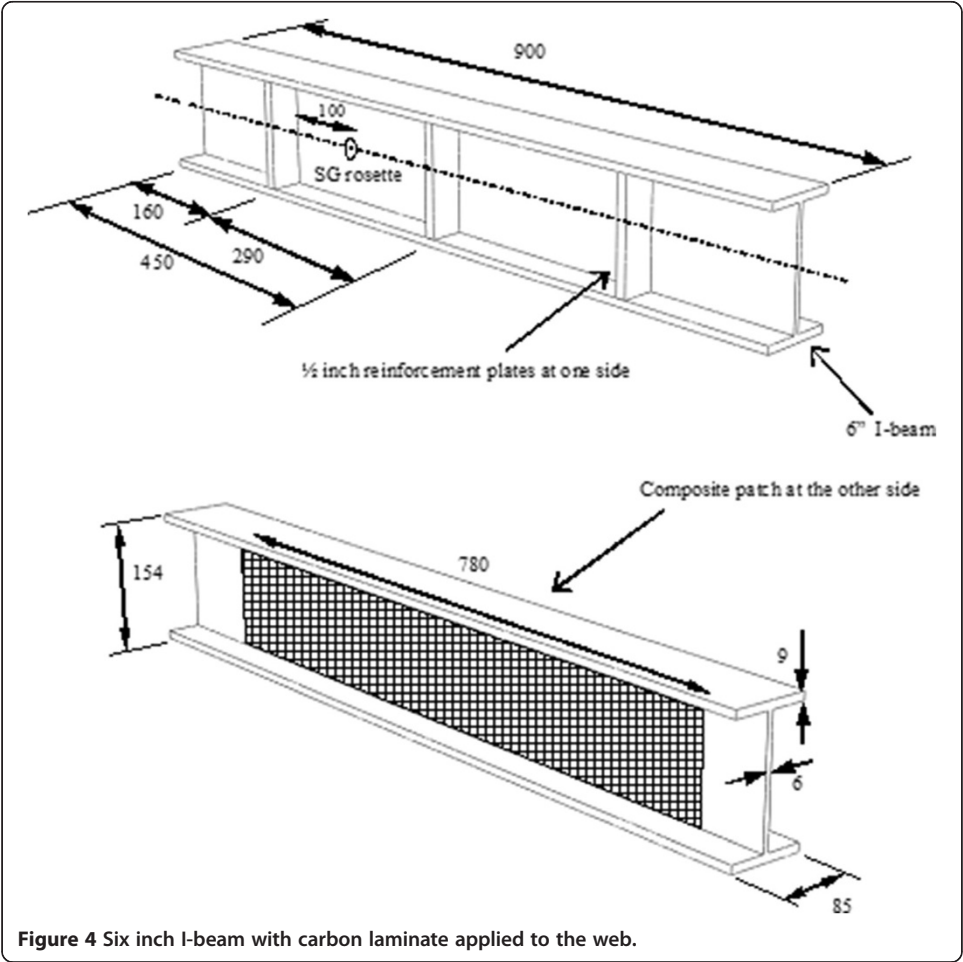
As the main objective of the repair was to reinforce the hull regarding shear stresses, after the lap shear evaluations three points bending tests were performed on 6 inch I-beams, with and without composite reinforcement. The composite patch was applied to the web of one beam, with a $+45^\circ/-45^\circ$ fiber alignment for optimal shear reinforcement. Eighteen layers were deployed, resulting in 9.2 mm of structural carbon laminate and a 0.6 mm thick adhesive layer. The capacity of the load frame limited the size of the beams. Nevertheless, the analysis concept remains the same no matter how large or small the metallic structure is. Figure 4 shows the reinforced beam sketch.

Both beams were monitored by rectangular strain gage (SG) rosettes applied at the position shown in Figure 4, in order to evaluate the stress field at that point of maximum shear stress. Figure 5 shows both beams at the three points bending experimental setup.

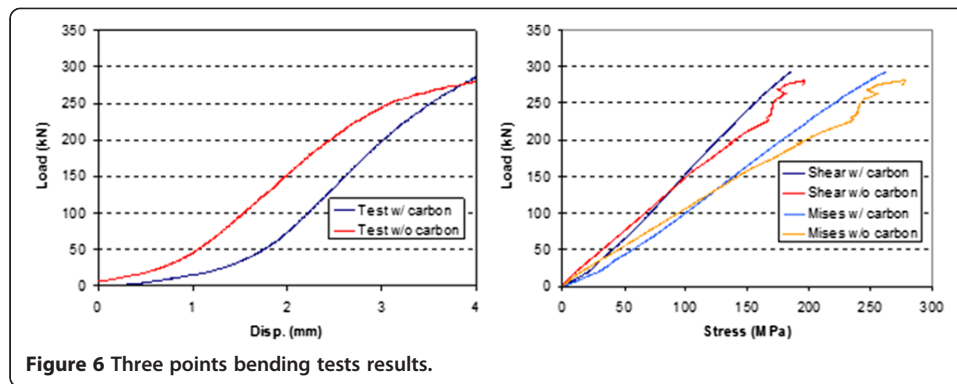
The test results, in terms of loads, displacements and stresses graphs are shown in Figure 6. There was a nonlinear displacement behavior at the beginning of the tests, due to gap closure and geometric accommodation of the beams to the test rig. A plastic load regime started to develop towards the ends of both tests, notably for the unreinforced beam.

The SG rosette applied to the unreinforced beam displayed a beginning of plasticity and some erratic behavior above 150kN load level. Nevertheless, an elastic regime was captured between 100kN and 150kN for both tests, so this load range provided the basis for results comparison. Between those two load levels there was an increase in shear stress of 35 MPa for the unreinforced beam and of 27 MPa for the reinforced beam. In conclusion, the 9 mm thick carbon laminate bonded to the web caused a 23% reduction of shear stresses at that instrumented point.

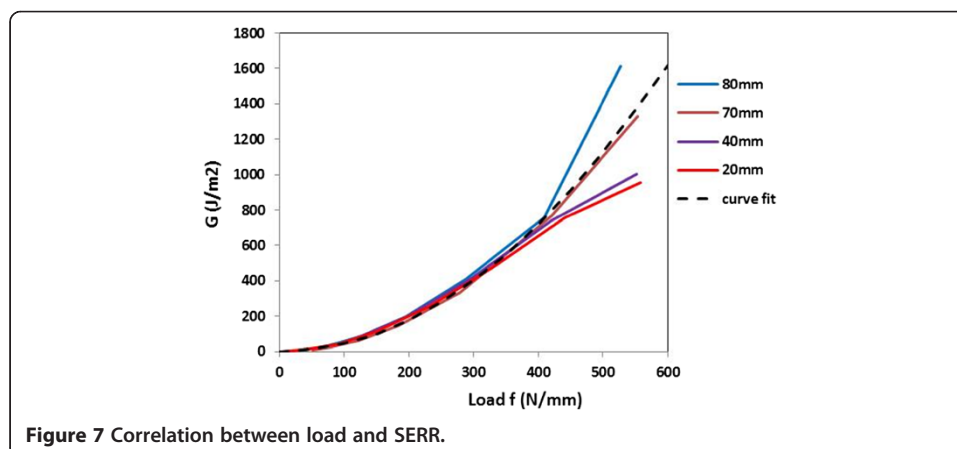
For the present DLS test setup, G was evaluated for several different defect sizes, namely 20, 40, 70 and 80 mm, selected to leave an overlap length still greater than the maximum effective, 100 mm. The models simulated a 5% increase in defect area and the SERRs were computed for the defect sizes indicated in formula (4). The models results, relating the unit load f to G are shown in Figure 7.

load range G is independent of defect size and a parabolic curve fit, shown as a dashed line in Figure 7, gives a conservative estimative of G values for defects up to 70 mm in size, even for load levels above 400 N/mm.

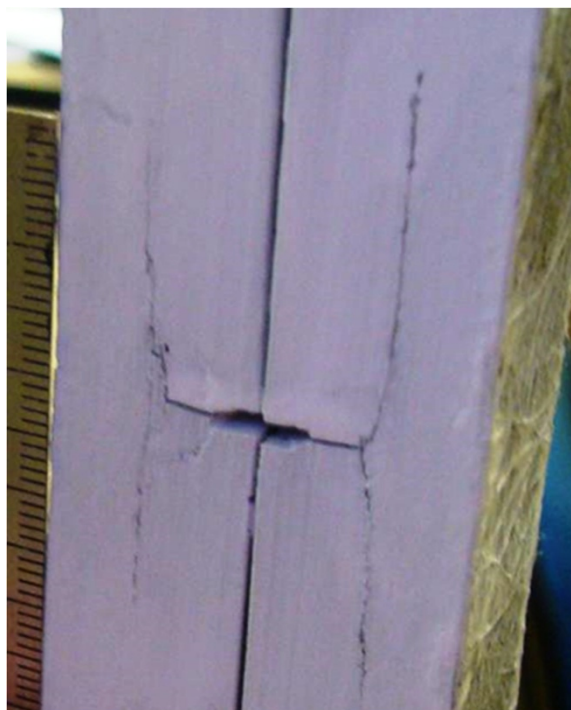
Figure 8 Fatigue test, showing defect propagation.

Having determined the relation between f and G , several defect propagation DLS tests were done at a servo-hydraulic test machine, keeping constant the maximum load and a load ratio of 0.1. For the fatigue tests the carbon laminates were not cut, in order to provide sufficient length for defect propagation and still allowing enough room for the maximum effective overlap length of 100 mm. The frequency was 10 Hz and laminate temperatures were controlled in order to avoid over-heating. A white paint was applied to the side of the specimens, as shown in Figure 8, to make defects visible.

In the beginning there were no initial defects but as soon as the tests started there was a rapid defect nucleation at the center of the specimens, followed by stable propagation. As discussed above, for defects up to 70 mm in length, G is considered independent of defect size and is obtained from the unit load f through the dashed curve of Figure 7. The parameter adopted for fatigue evaluation was the maximum G reached in each cyclic test [7]. As the specimens were tested in pairs, each test provided four defect fatigue propagation results. Defect size was the average of two defect tip measurements, from the front and back faces of specimen.

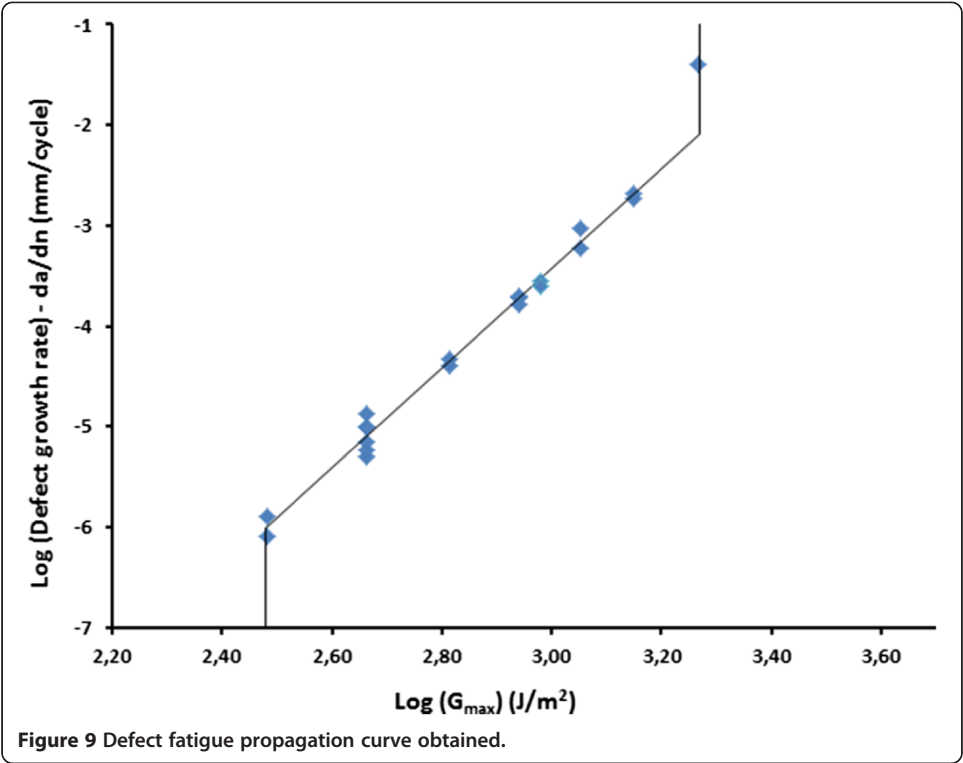
Fatigue test results are displayed at Figure 9, as a log-log diagram of G_{\max} versus defect propagation rate da/dN (Paris law). As indicated at the graph, a threshold of $\text{Log}(G_{\max}) = 2.5$ was assumed. This corresponds to an extremely low propagation of one nanometer per cycle and means that defects providing G_{\max} equal to 317 J/m^2 or less would practically not grow due to fatigue. It is recalled that the fatigue tests were performed under a load ratio of 0.1. The experimental data provided by Alegri et alii [8] indicate that higher load ratios would lead to higher thresholds.

The strain energies given by the models both before and after defect growth were obtained and the SERRs were calculated as indicated by expression (4). For the smallest defect it resulted to be 69.7 J/m^2 and for the largest, 67.4 J/m^2 . The load case in study is a maximum one, with very few occurrences, but even if it were frequent the defects would not grow in fatigue, as the threshold is 317 J/m^2 .

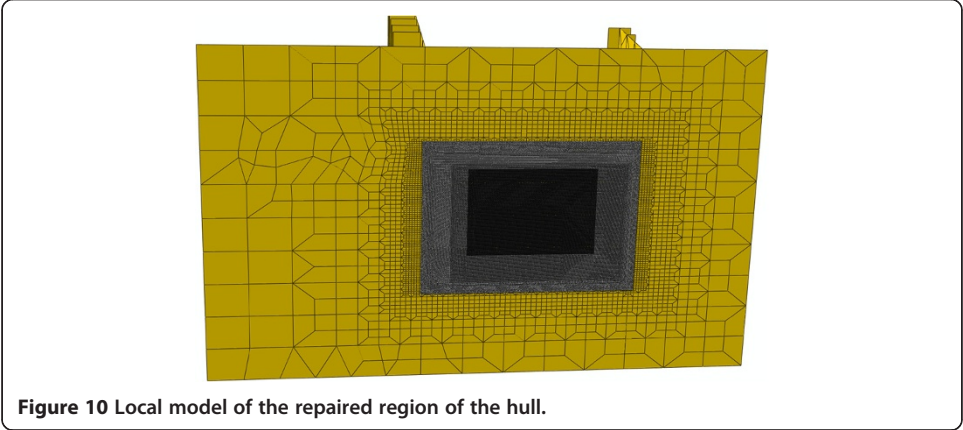
Figure 10 Local model of the repaired region of the hull.

In order to optimize carbon fiber consumption the repair was divided in three parts, as displayed at Figure 10. The characteristics of the 3 laminates are shown at Table 2.

#	Length (m)	Height (m)	Number of layers	Carbon thick. (mm)	Equiv. steel thick. (mm)
1	5.5	4.0	30	18.0	3.9
2	4.4	3.1	17	10.2	2.2
3	3.3	2.3	16	9.6	2.1

The lamination went from the largest layer to the smaller, with size decrements from sheet to sheet to provide thickness tapering at the borders.

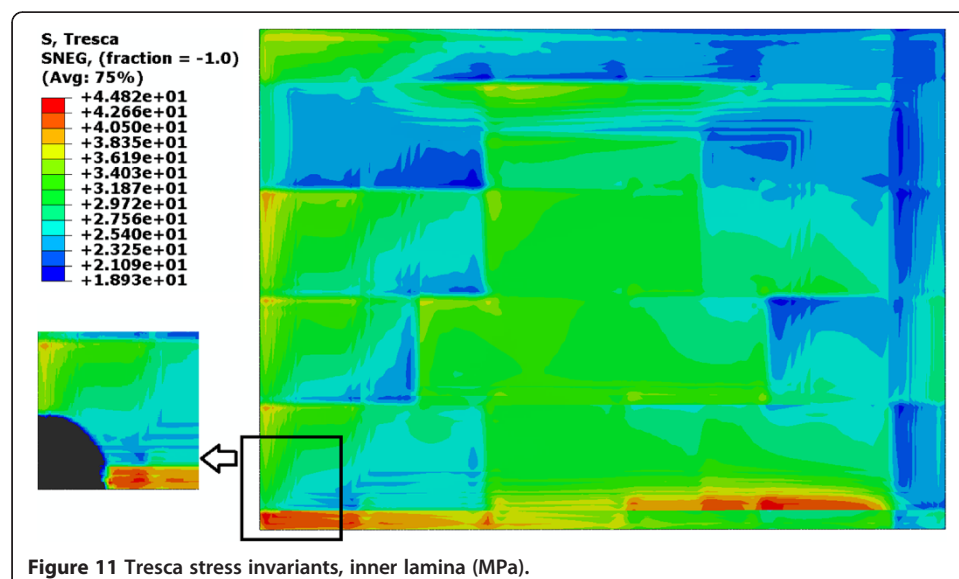
Figure 11 Tresca stress invariants, inner lamina (MPa).

The total carbon thickness effectively deployed was 37.8 mm. The adhesive interface properties discussed in section FEM simulation of the DLS tests were introduced into the hull repair model, for load case 4. As already explained, the composite repair FEM grid is simply superimposed to the steel one. The plate element size for the composite repair is 25 mm. The results, in terms of Tresca stress invariant, are shown at Figure 11, for the inner laminate surface, in contact with the interface.

After the repair stress field was obtained for this load case, some circular defects were simulated at the rightmost, lower repair corner, where the Tresca stress invariants were largest, as indicated by the inset at Figure 11. The defects simulated disbondments between steel and composite, starting at the edges. Two defect sizes were simulated: 200 and 500 mm in radius. Then, similarly as it was done for the simulation of DLS tests, the defects were considered to have grown about 10% in area.

Data processing indicated that dynamic stresses experienced by the repair along 2013 were well below the maximum values indicated the FEM model for the load case show at Figure 11, as in this case the maximum Tresca stress invariants at positions where strain gages were installed at the composite repair was 36 MPa. The histogram of Figure 12 shows high frequency (periods from 5 to 15 s) Tresca stress ranges at the repair, measured by sensor number 10 along July 2013, when they were the highest.

It can be seen from the graph that long term stress ranges sometimes approached the maximum load case illustrated in Figure 11, but as shown before, it is still well below the fatigue threshold. So, the monitoring results also indicate that eventual defects that exist at the metal/composite interface will not grow due to fatigue.

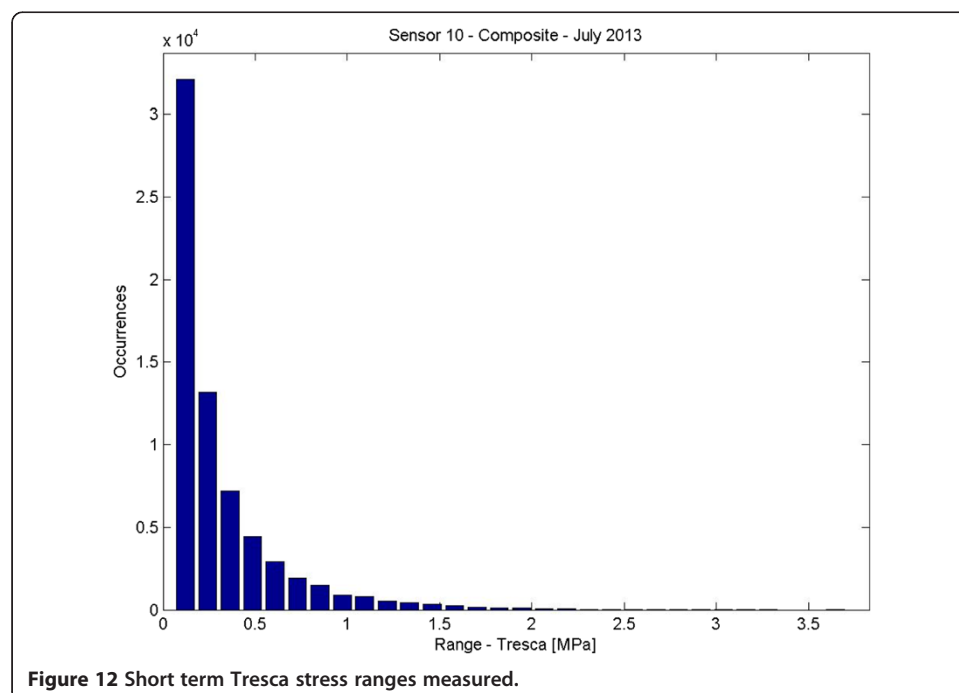
The histogram above is related to loads caused by short term wave, wind and current loads. As the monitoring system is based in optical strain gages, long term variations due to oil tanks levels, temperature changes, ship weathervane, sea states, storms, etc. were also captured. It is shown at Figure 13, which displays average Tresca stress measured by sensor 10, from March to December 2013.

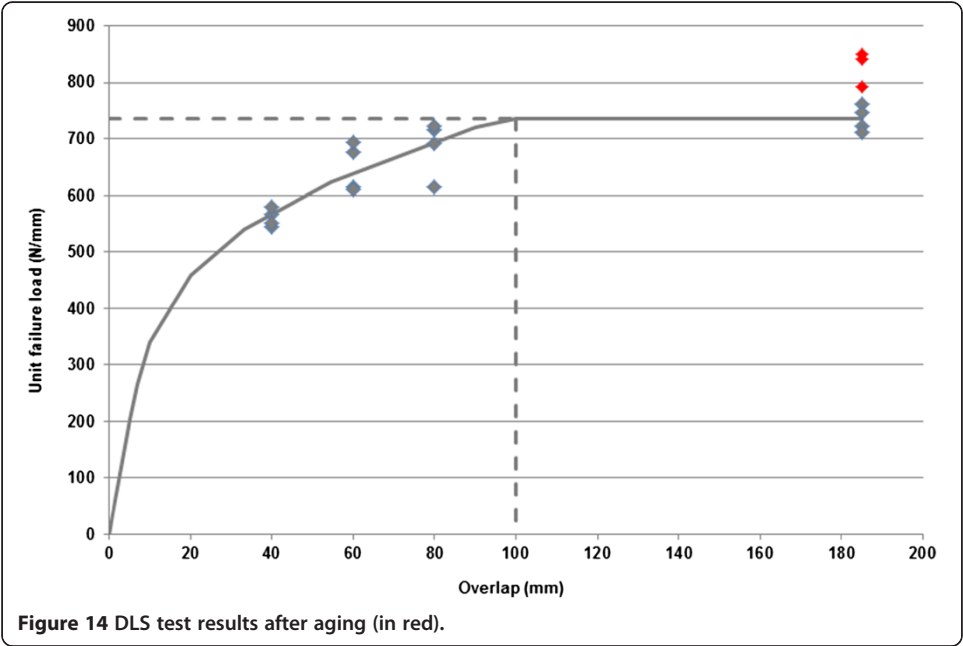
At the end of that period there was not any visual indication of degradation of the reinforced plate, so only the UV exposition remained, and lasted for eight months more. After that, three extra DLS tests were performed, in order to address any modification of the interface behavior. These specimens had long overlaps, i.e., there were not any cuts in the carbon laminates. These test results are shown in red at Figure 14, superimposed to the original ones, shown in grey color at the graph.

As can be seen, the aging process caused an improvement in interface properties, as the unit failure load increased from 736 N/mm to an average value of about 830 N/mm, a 12% increase factor. What the aging test has shown is that the repair itself provided an efficient barrier against the environment and protected the interface from any chemical or physical attack. The improvement of unitary failure load with time thus indicates a
